CCD's post shipment blemish and cosmic ray

In this paper, we will discuss the main study performed at IBM, as well as an analysis performed by the Sony to relate this phenomenon to CCD manufacturing.

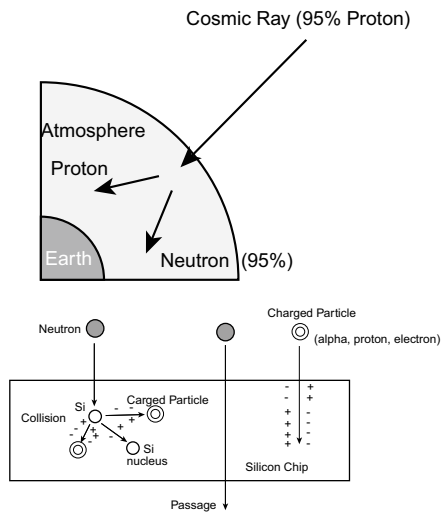
It is well known that memory chips (MOS or CMOS structure) experience occasional errors at random memory cell locations. The errors are transient; once the cell is refreshed, the error is corrected. This type of temporary defect is called a "soft error." One of the primary causes behind this phenomenon is natural radiation from Alpha particle sources. The major sources of Alpha particle emission have been found in the semiconductor material itself, as well as the materials used in packaging the die, and natural radiation from the ground (i.e. Radon.) In the IBM study, however, it was revealed that Cosmic Radiation also plays a significant role.

Alpha particle emission within the semiconductor material itself is negligible today, due to continuous improvements in semiconductor and packaging materials over the years. Cosmic Rays, however, continue to be a rare, but nonetheless harmful, source of radiation. Cosmic Rays, which are 95% protons, collide with the atmosphere to create energetic neutrons. The high-energy neutrons are capable of penetrating buildings, even those constructed with concrete walls up to 200 meters thick. When energetic neutrons strike silicon, the majority pass through without causing damage. If the energetic neutron happens to strike a nucleus in the silicon lattice, however, it results in the creation of charge particles. In the worst case, the collision can cause a dislocation of the silicon atom in the lattice.

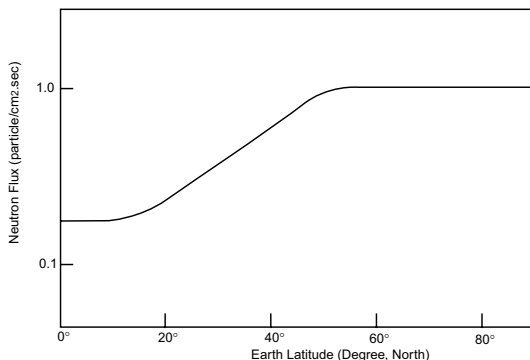
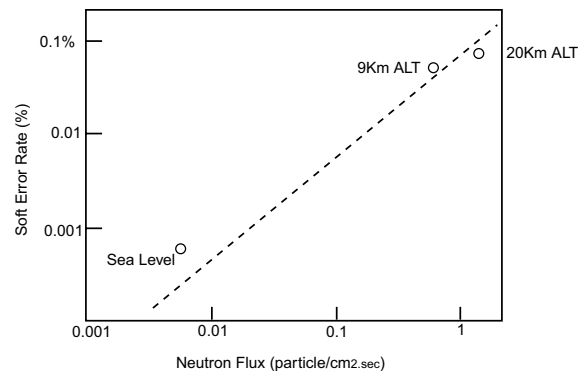
Neutron Density

The IBM study shows that the soft error rate is proportional to the density of the incident energetic neutrons. The magnetic field of the earth forms a dipole, which causes the cosmic ray density at the surface of the earth to be highest near the poles, and lowest near the equator. Altitude also effects cosmic ray density. The neutron density at an altitude of 20,000 meters is nearly 100 times greater than that at sea level.
